Part Change Notice: Detect Switch and Cover Plating Change

Part Number
ST11S008V4HR2000

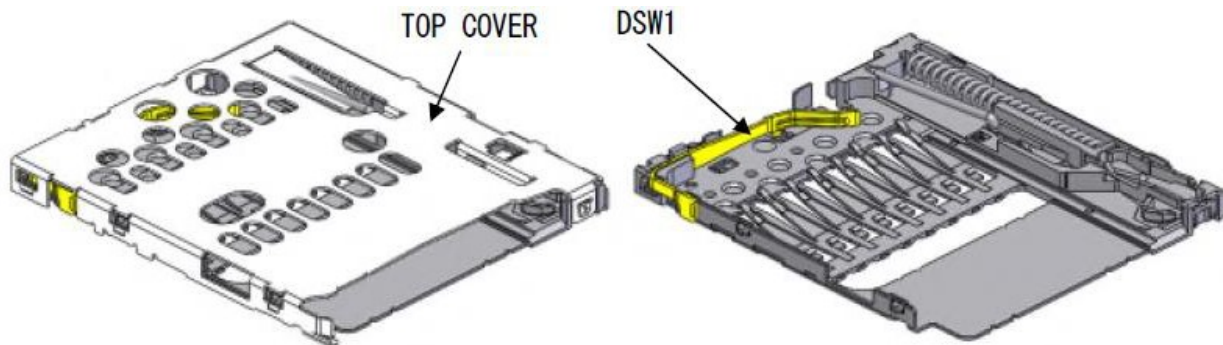
The current plating on the components works well in most conditions, but when used with solder with good wettability at low temperatures, DSW1 (detect switch 1) can potentially wick up solder and stick to the top cover which will not allow normal functionality of the detect switch.

Part	Revision	Location	Specification
Top Cover	Current	Japan Factory	Au (0.03um min)
	New	Same factory, different line	Au (0.03um min) over Ni (0.5um min)
DSW1	Current	Japan Factory	Au (0.03um min) over Ni (1um min)
	New	Different Japan Factory	Au (0.03um min) over Ni (1um min)

In order to prevent this, the selective plating of DSW1 is changed to further limit the Au plating to only the necessary areas. Please see below for more details on the change.
