# CC1310 SimpleLink™ Ultra-Low-Power Sub-1 GHz Wireless MCU Silicon Revisions B, A

This document describes the known exceptions to functional specifications (advisories) for the CC1310 SimpleLink™ device.

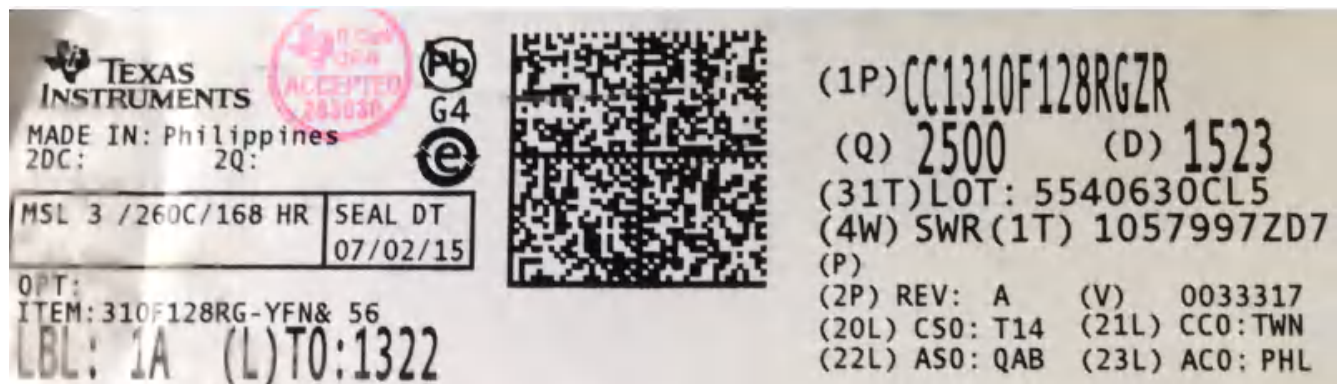
**Figure 2-3. Sample Product Shipping Label for CC1310 Device**

- Package label:
  - The die revision name is shown on the tape and reel label as shown in the example label in [Figure 2-3](#).
  - Entry (2P) lists the revision (either A or B).
